Safety Notice Compilation

All Pilots and Operators are required to read the enclosed Safety Notices prior to any flight or operation of WACO YMF-5 or 2T-1A-2 series aircraft

Master Document Revision: 8 September 25, 2019

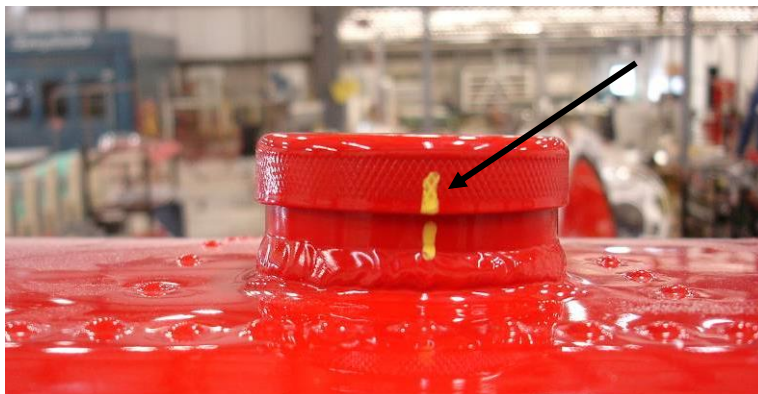
Several times a year WACO receives orders for replacement fuel caps that have departed the airplane in flight. Each fuel cap is attached to the tank filler neck by a retainer chain. The retainer chain is only intended to keep the cap from sliding down the wing during refueling and not to secure the cap during flight. Unfortunately, this chain also contributes to damage to the top of the tank as a loose cap that becomes detached from the filler neck will often slap against the tank skin causing extensive damage. Due to the violent nature of the flailing cap, the retainer chain will not prevent the cap from departing the airplane. Loss of an object from the aircraft may pose a hazard to the aircraft, by blocking or jamming flight controls, and to persons or property on the ground or aircraft in trail

Photo above of line on fuel cap and neck at fully closed position

When fueling the aircraft, fueling persons should be especially diligent to confirm that the cap is firmly against the rotation stop. Additionally, the fit should be snug and unobstructed by the retainer chain.

Some owners have marked the proper stop location with a visual line on the filler cap and neck. This serves as a visual indicator for the cap closed position. While this visual indicator is a helpful aid, physically verifying the cap is against the stops is the best method to confirm good closure.

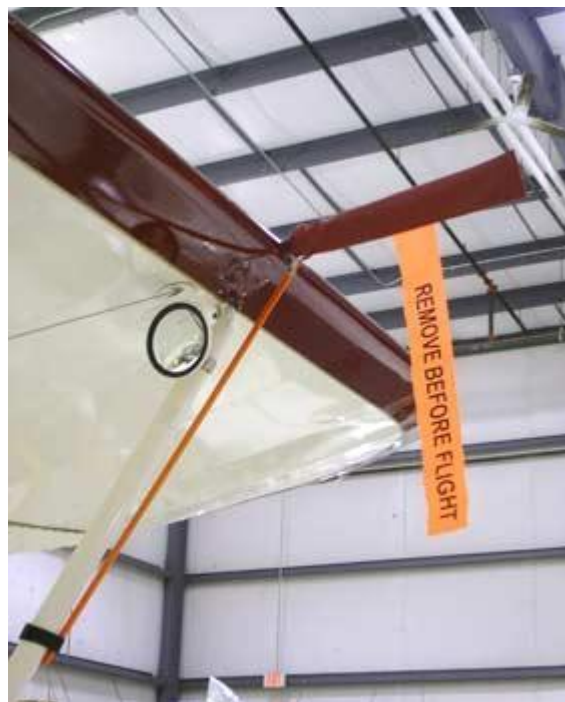
Approved WACO pitot cover

The only factory approved pitot cover for the WACO-YMF can be found at the WACOGear.com webstore: <http://www.wacogear.com/pitot-tube-cover/>
