Safety Notice Compilation

All Pilots and Operators are required to read the enclosed Safety Notices prior to any flight or operation of WACO YMF-5 or 2T-1A-2 series aircraft

Master Document Revision: 7 November 12, 2018

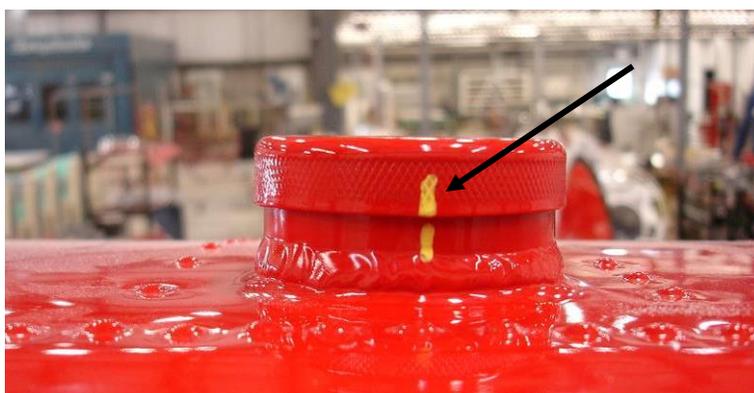
Some owners have marked the proper stop location with a visual line on the filler cap and neck. This serves as a visual indicator for the cap closed position. While this visual indicator is a helpful aid, physically verifying the cap is against the stops is the best method to confirm good closure.

Photo above of line on fuel cap and neck at fully closed position

When fueling the aircraft, fueling persons should be especially diligent to confirm that the cap is firmly against the rotation stop. Additionally, the fit should be snug and unobstructed by the retainer chain.

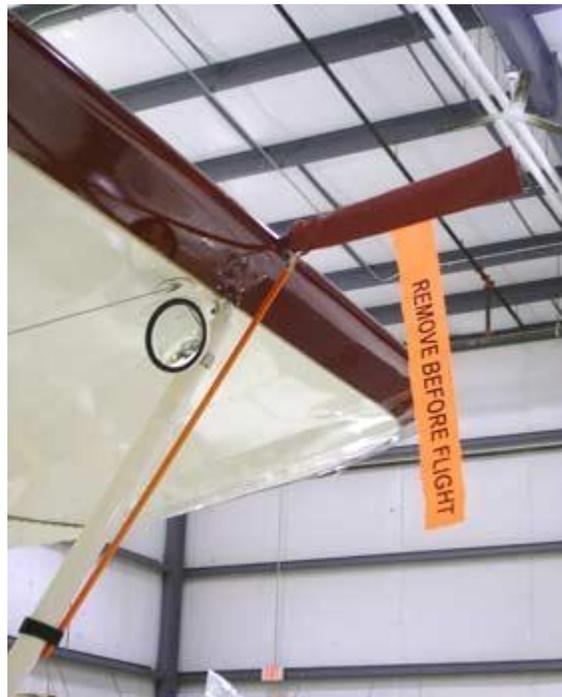
Approved WACO pitot cover

The only factory approved pitot cover for the WACO-YMF can be found at the WACOGear.com webstore: <http://www.wacogear.com/pitot-tube-cover/>
