WACO Great Lakes 2T-1A-2

SERVICE BULLETIN

NUMBER: GL-SB0002

SUBJECT: Center Section Former Rib Cracks

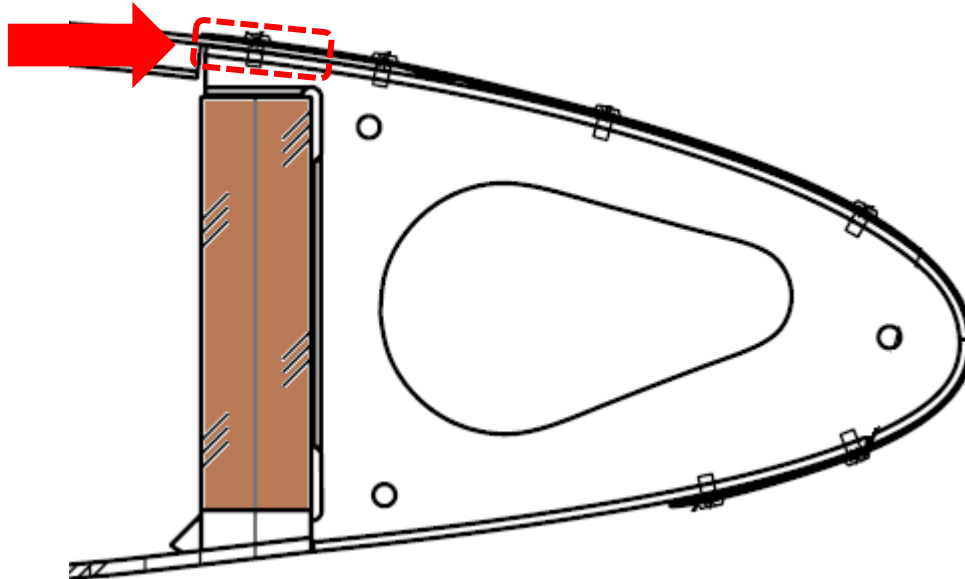
Figure 1 - Nose Rib Former Inspection Location

Field reports have identified the formation of cracks in the former ribs (in the leading and trailing edges) of the center section assembly. These cracks have been reported on aircraft subjected to energetic maneuvering flight. There has been no observed effect on flight.

- c. Inspect the upper flange of each of the five (5) leading edge former ribs for cracks. Cracks are most likely to form in the radius of the top flange at the aft end of the rib, over the spar. Refer to the following figure:

NOTE: If cracked ribs are identified they must be replaced. During replacement, the center section is changed from the 30116-100 configuration to the 30116-104 configuration. All four (4) existing fabric supports are replaced with 30116-106 fabric supports.

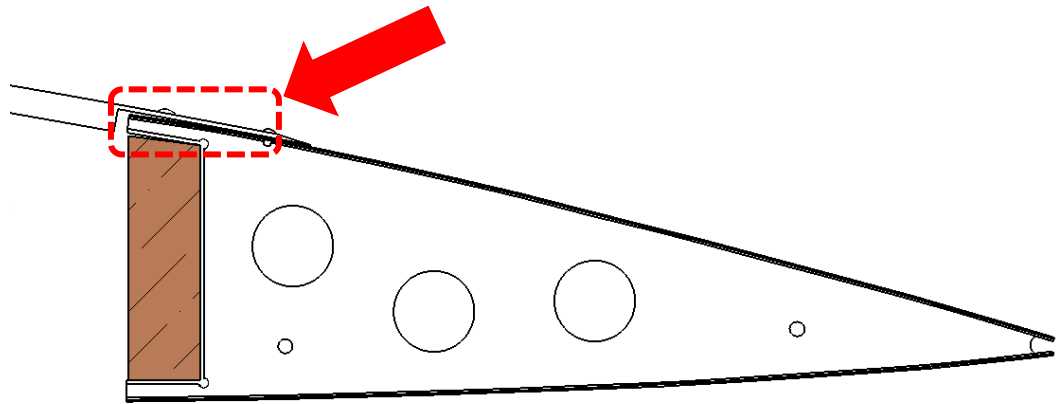
Figure 2 - Trailing Edge Rib Former Inspection Location

Note: It is permissible to add inspection covers to the bottom surface of the center section trailing edge. Inspection covers are standard size (3-9/16" ID) and may be sourced independently or from WACO Aircraft.
 - b. Route the borescope to the upper surface of the center section rear spar at the rib attachment location.
 - c. Inspect the upper stress relief radius of each of the four (4) trailing edge former ribs for cracks. Cracks are most likely to originate from the stress relief radius at the top side of the spar clearance hole. They have also been observed in the radius of the top flange at the aft end of the rib, over the spar. Refer to the following figure:
