GLAC SERVICE INSTRUCTION #1

GLAC SERVICE BULLETIN #2

GLAC SERVICE LETTER #3

GLAC SERVICE BULLETIN #4

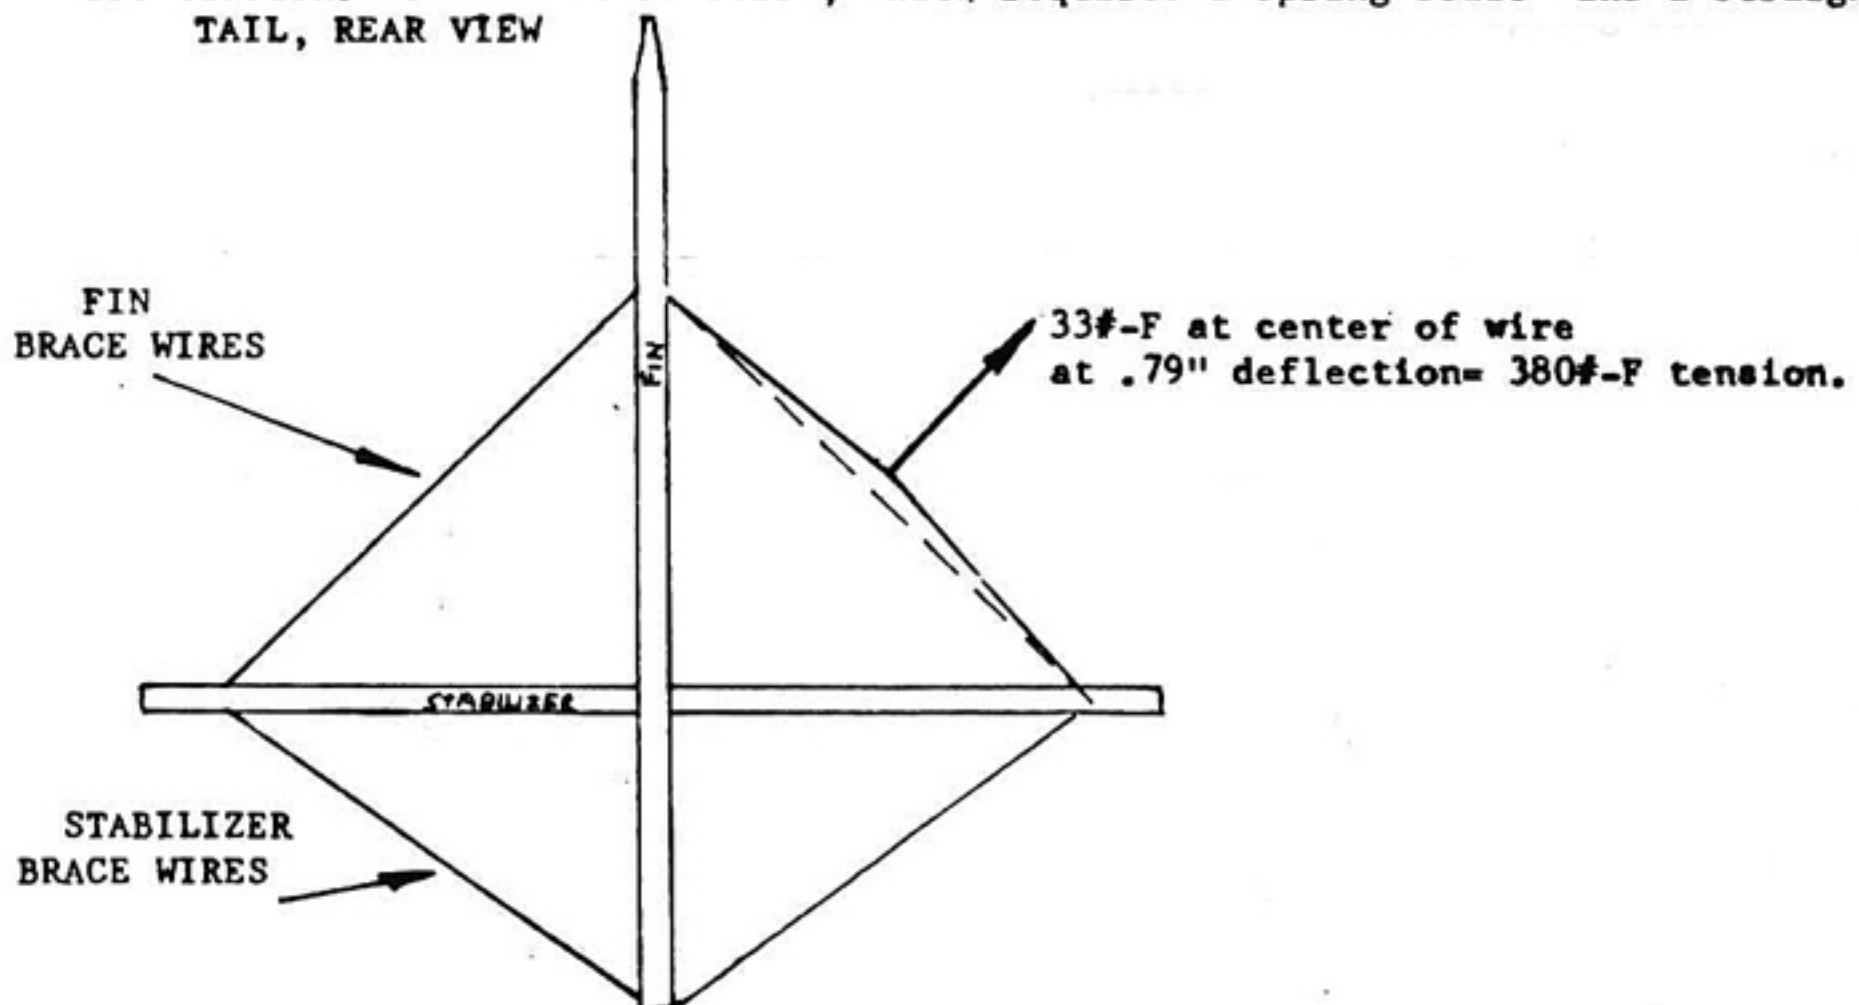
TAIL, REAR VIEW

It has come to our attention that field adjustment of fin brace wires may cause different tensions between wires on the same side of the fin.

Fin brace wire tension can be checked two ways: one, by using a flying wire tensiometer, which incorporates the deflection, and reads out directly in #-Force wire tension. Or the method below, which requires a spring scale and a straightedge.

The proper procedure is as follows; With the stabilizer trimmed in the normal flight position, approximately centered, the bolt attaching wire lugs thru the stabilizer is tightened until lugs will not rotate, then backed off 3/4 turn --- this will allow lugs to "pivot" during flight trim adjustments.

The wires are then adjusted to the proper tension: 380 #,  $\pm 25$ .

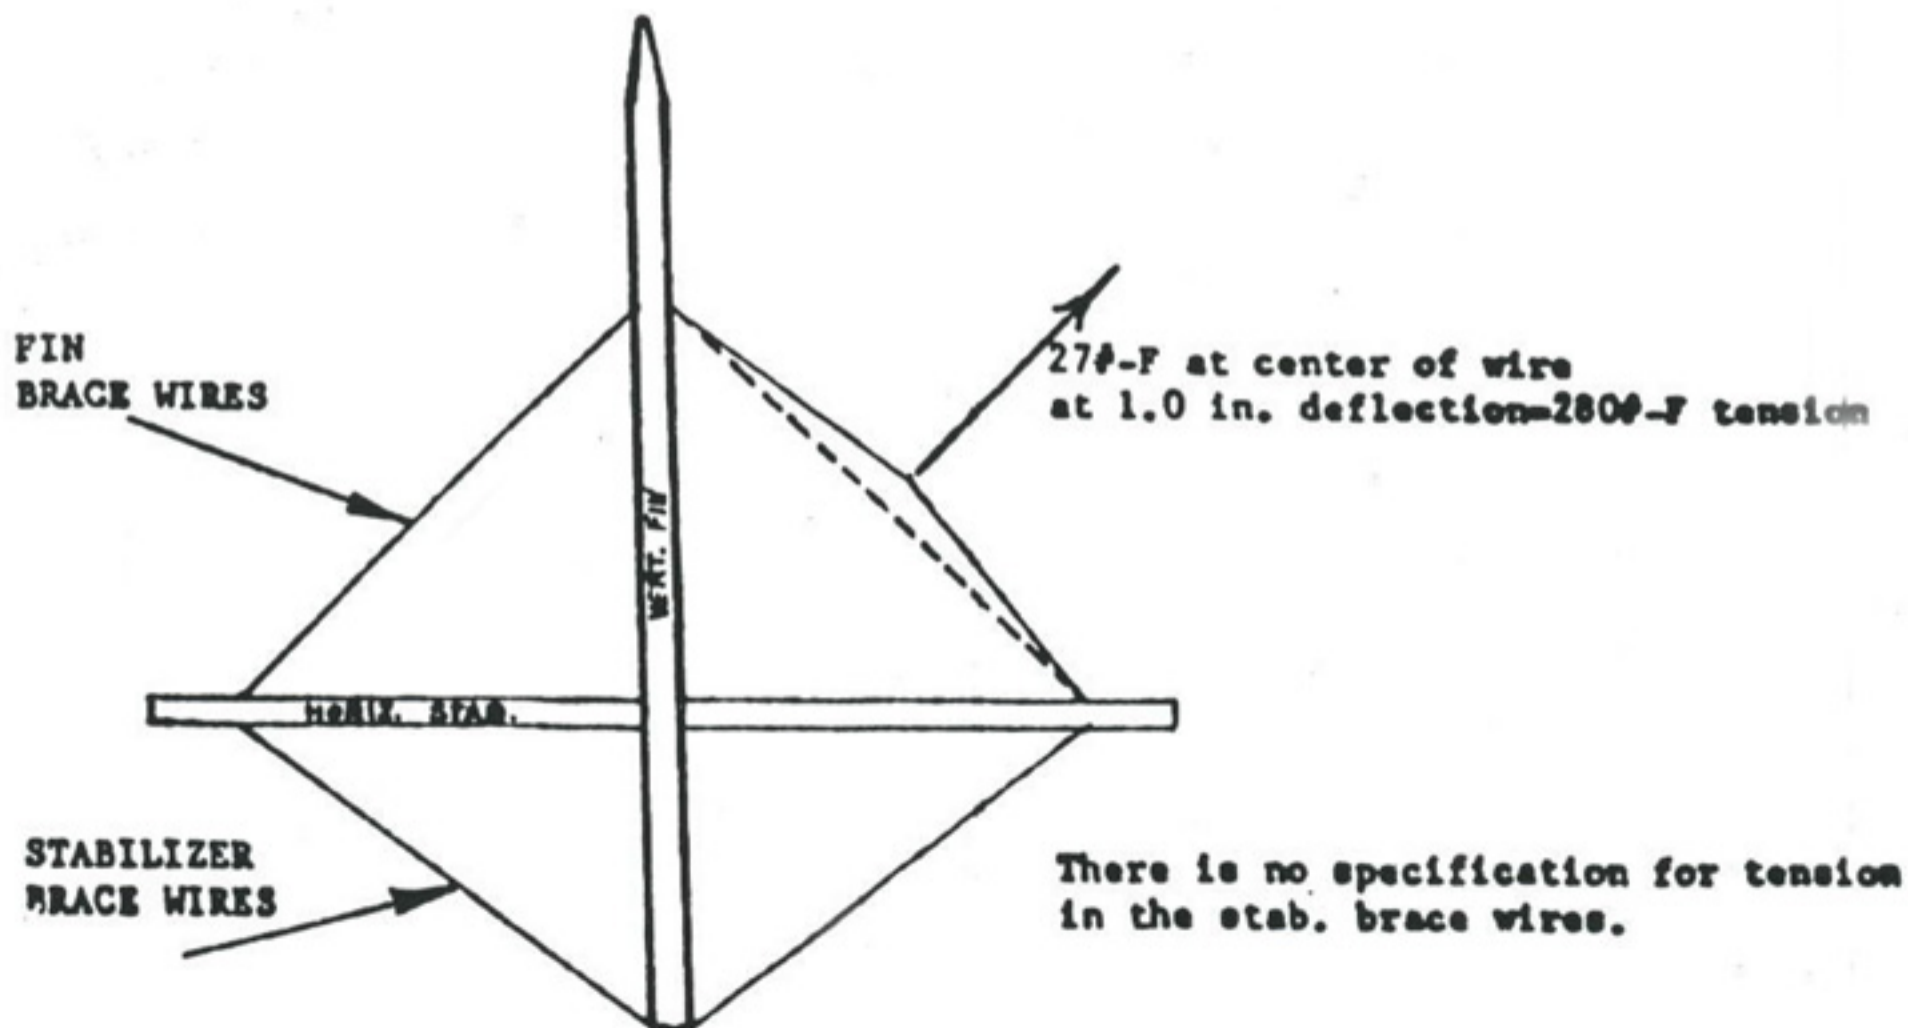
SUBJECT: CORRECTION OF SERVICE BULLETIN #4

Fin brace wire tension can be checked two ways: one, by using a flying wire tensionometer, which incorporates the deflection, and reads out directly in  $\phi$ -Force wire tension. Or the method below, which requires a spring scale and a straightedge.

PLEASE NOTE THE CORRECT TENSION IN THE FIN BRACE WIRE IS TO BE  $280\phi \pm 25$ .

Procedure: install all parts loosely, then tighten bolts through fin. Tighten all wires just until all slack is removed. With stabilizer centered, tighten the bolt through the stabilizer until the lug (10116-1) will not rotate, then back off the nut 3/4 turn. This will allow the lugs to pivot during trim adjustments. Progressively increase tension on all wires keeping elevator hinges perfectly in line; this may be checked with a string pulled taut. The lower wires adjust this, while the fin brace wires do more to move the fin itself. With the aircraft level laterally and longitudinally, the fin should be vertical (plumb).

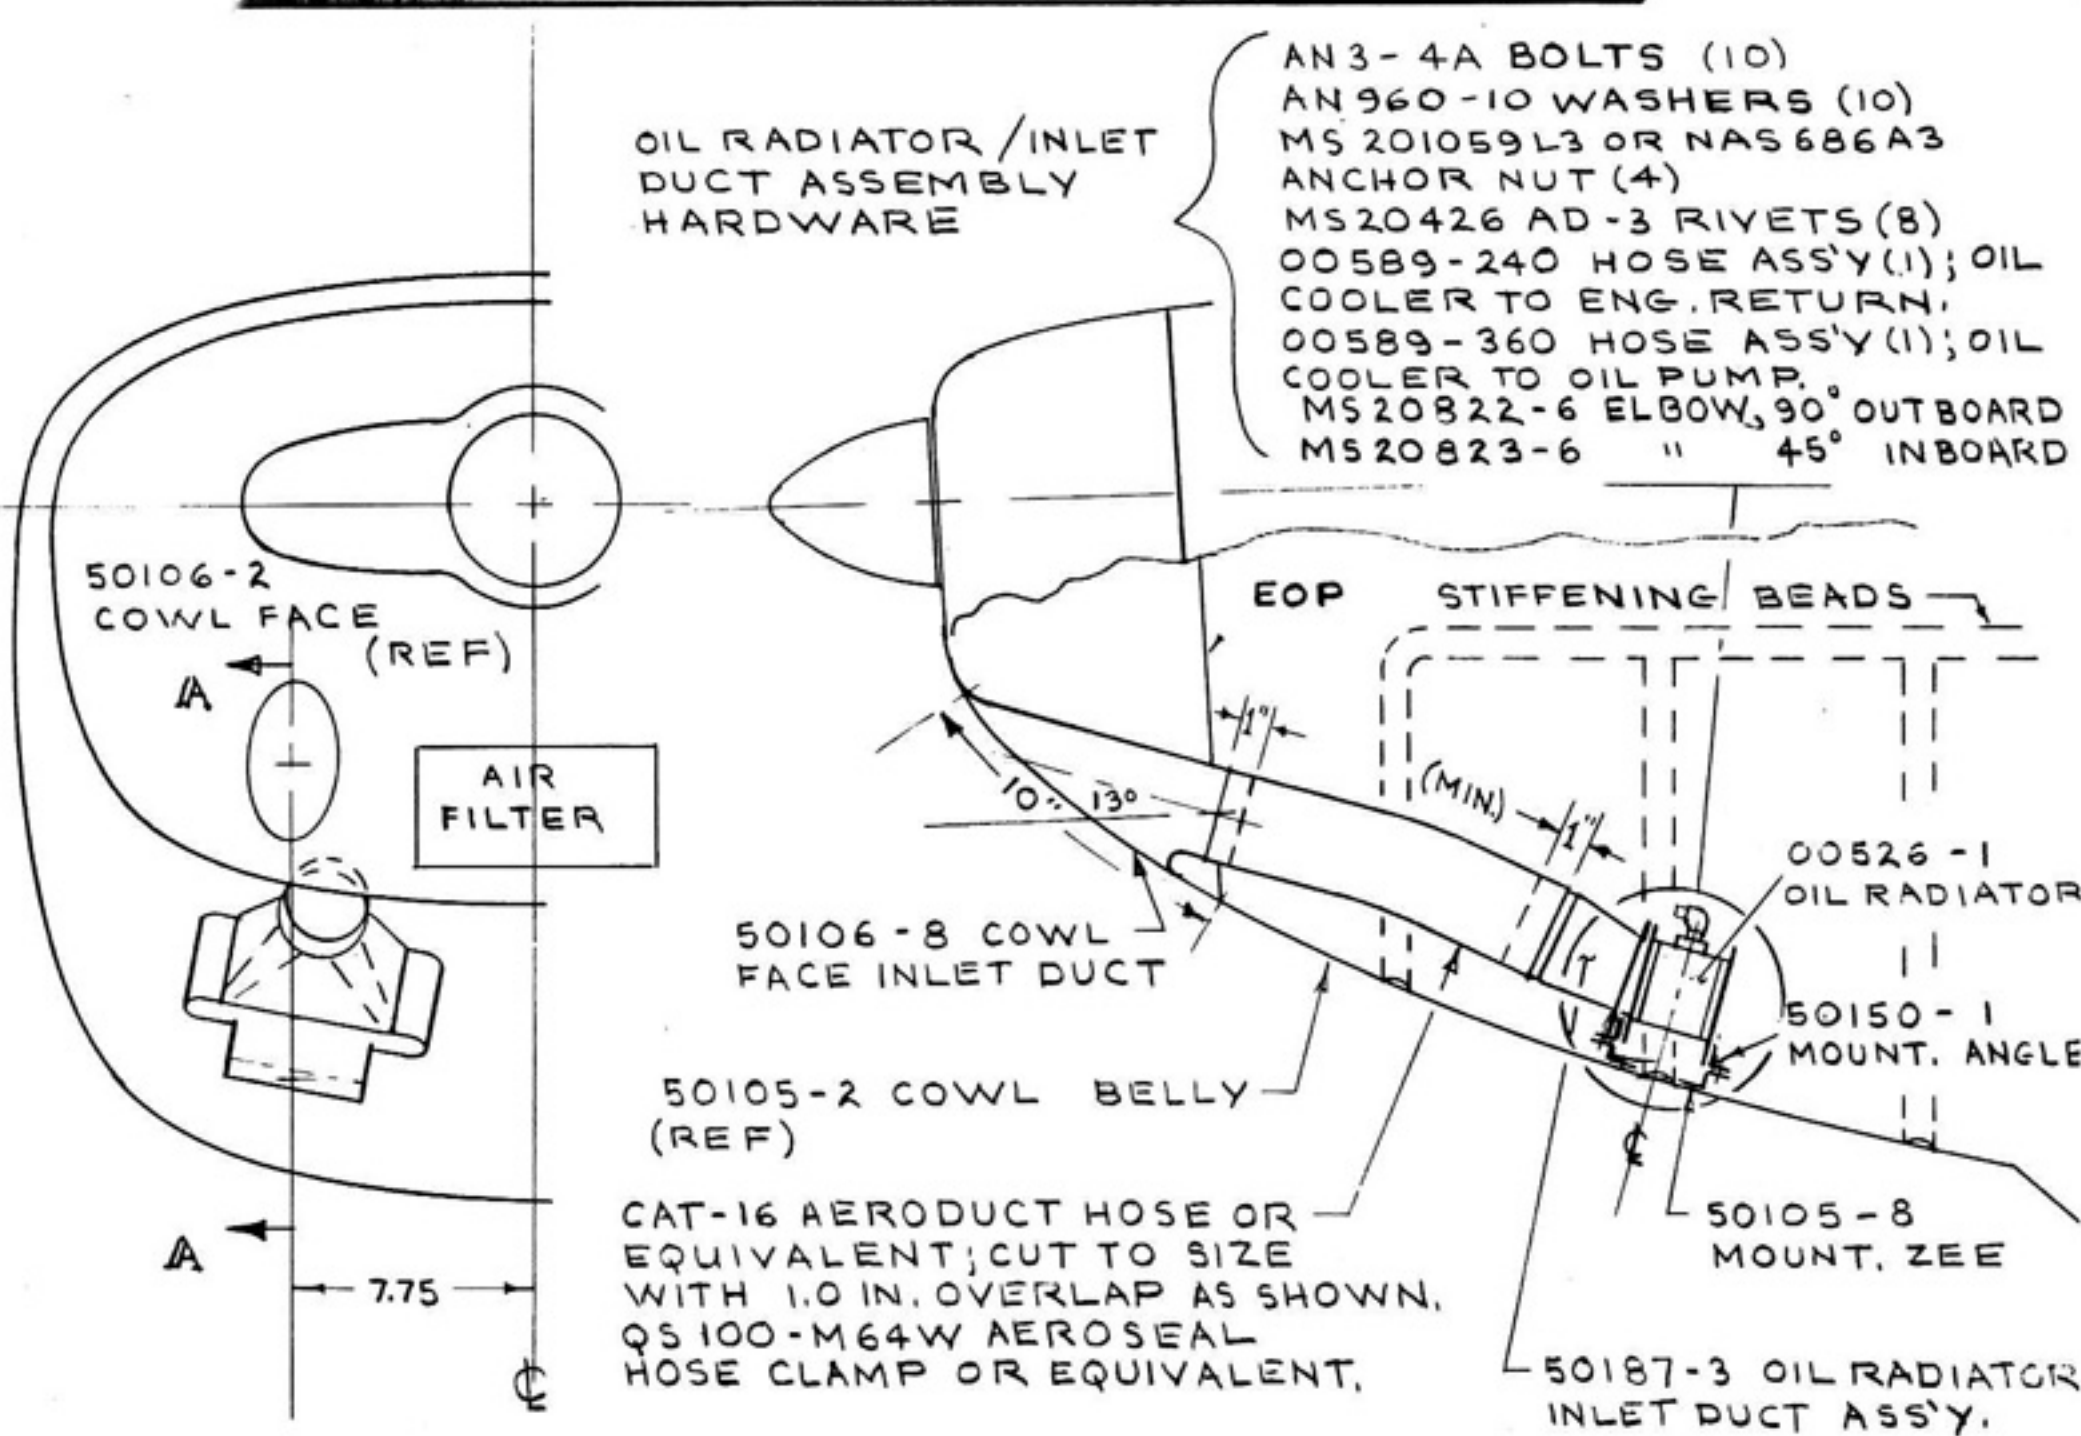
# OIL COOLER SYSTEM INSTALLATION SCHEMATIC

It consists of a new four inch diameter fiberglass inlet duct installed in the nose cowl to inlet ambient air through a four inch diameter hose directly into the oil cooler radiator which is remounted inside the bottom of the belly cowl.

The new oil cooling system allows the owner to use the oil radiator originally installed in the airplane. Fiberglass and paint work to the lower cowl and nose cowl will be required in order to bond the oil radiator mounts to the cowl and to install the cowl face inlet duct.

A service parts kit SPK101 is now available from the factory at our factory cost of \$249.95. This kit consists of a fiberglass inlet duct, an oil radiator inlet duct, all mounting brackets, a longer oil hose, a baffle cover plate and all the miscellaneous hardware required for the installation. Also, installation schematic diagrams and fiberglass bonding instructions are provided.

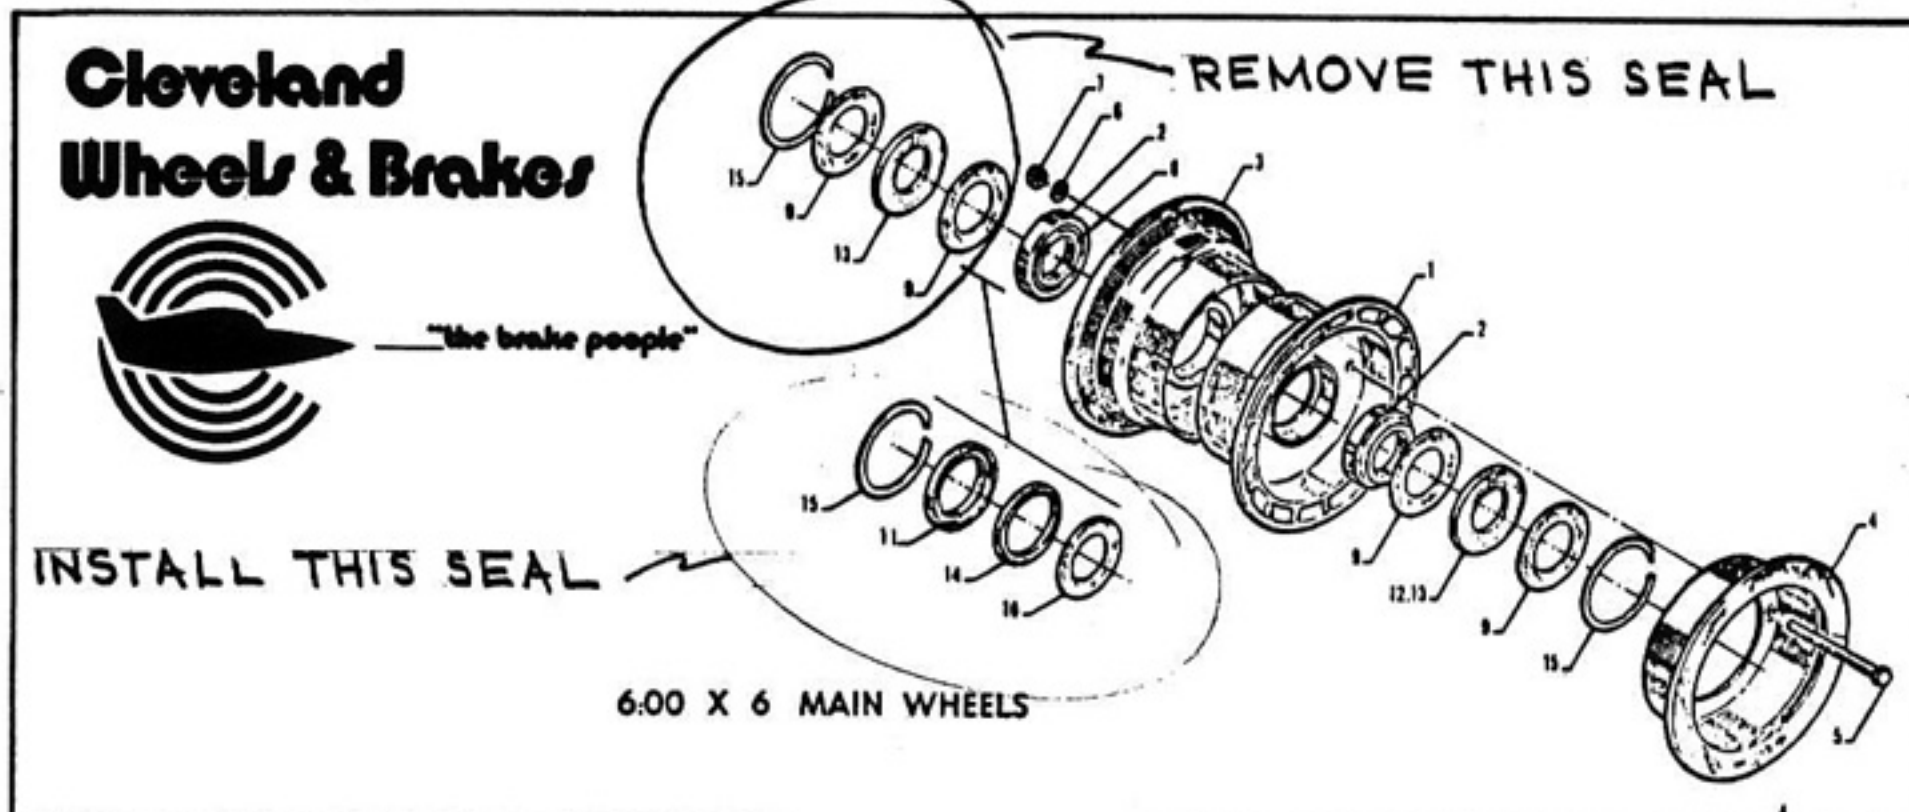
# "CLEVELAND AIRCRAFT" WHEELS & BRAKES

1. Inspect the interior relief of the wheel hubs for any damage due to the wheel retention nuts being installed against the outer grease seal washer.
2. Determine if any foreign materials are present in the main wheel bearings (repacking will be required).
3. Remove the -13 or -14 inner spacer; clean and inspect the axle.

1. Remove the flat type grease seal with its respective washers and replace with a U-type (saddle) seal assembly. Cleveland part numbers as follows (see page 2):

- 2.a. If a 20101-14 inner spacer is installed, it must be replaced with a -15. (A -14 has reduced diameters on both ends).
- b. If a 20101-13 is installed (identified by a reduced diameter on one end only) replace it with the reduced dia. on the INBOARD side.
3. Reassemble wheel & torque retaining nut to remove axial play. Ensure that the nut contacts the washer and clamps down on the bearing.
