GLAC SERVICE INSTRUCTION #1

GLAC SERVICE BULLETIN #2

GLAC SERVICE LETTER #3

GLAC SERVICE BULLETIN #4

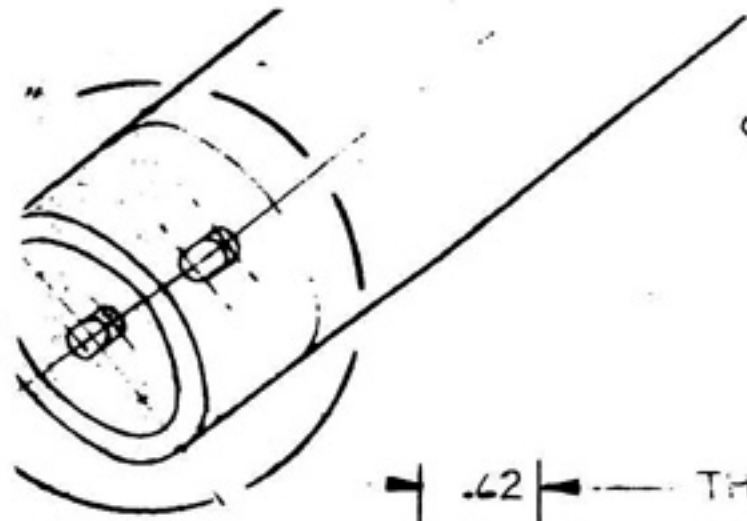
DETAILS; MAIN LANDING GEAR AXLE (DRAWING NO. 2010.L)

\* REPLACES -13 AND -14 SPACERS

- 2.a. If a 20101-14 inner spacer is installed, it must be replaced with a -15. (A -14 has reduced diameters on both ends).
- b. If a 20101-13 is installed (identified by a reduced diameter on one end only) replace it with the reduced dia. on the INBOARD side.
3. Reassemble wheel & torque retaining nut to remove axial play. Ensure that the nut contacts the washer and clamps down on the bearing.
